## WINDOWPANES FRAGMENTS FROM THE NORTHWEST NECROPOLIS CHURCH OF PAPHLAGONIAN HADRIANOPOLIS

**Abstract.** The Northwest Necropolis Church in Hadrianopolis, one of the cities of the Paphlagonia, is located southwest of the central area, 20 m northwest of the Bath B. Started 2017, excavations at the Northwest Necropolis Church were completed in 2021. The south and apse wall of the church came today at the foundation level, while the north and west came today at a height ranging between 1 m and 2 m. It is understood that the walls of the building were heavily damaged because of agricultural activities. Due to the extensive destruction of the body wall, no trace of the location, dimensions and position of the windows could be found. The only data about the windows are fragments of the windowpanes discovered during the excavations. Fragments of the windowpanes were unearthed in large quantities. The edges of some of the windowpanes were examined to get ideas about the frame. In addition, the paste residues that came today on the edges of some fragments were analyzed in lab to determine the ingredients. In this study, in the light of all datas, how the illumination in the Northwest Necr

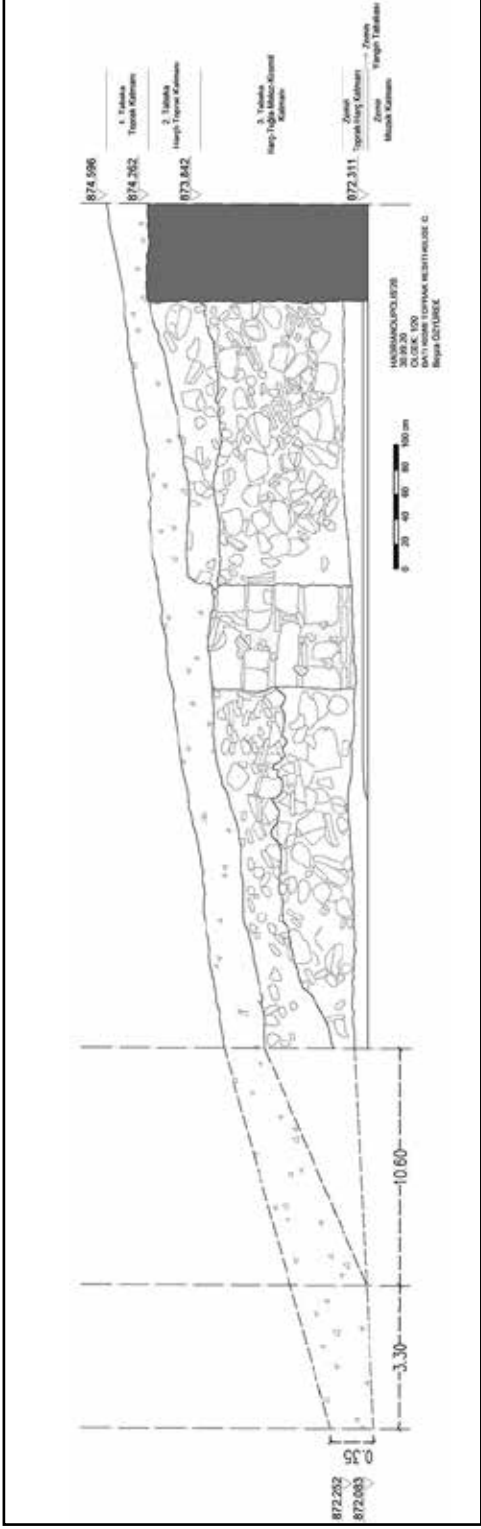
**Fig. 2.** The Stratigraphy of Northwest Necropolis Church (Hadrianopolis Archive)

The church has a major change about 100 years after it was built; and the excavations revealed that the church has a stratigraphy consisting of four layers (Fig. 2). The stratigraphy and architectural details indicate that the first construction phase of the church was between the 4<sup>th</sup>–5<sup>th</sup> century AD and that it was destroyed by an earthquake or fire [3, p. 14–15]. In 2019, a large amount of glass was found in the northeast of the church, in the part of the body wall facing the outside. The majority of these fragments are of poor quality and are thought to be production residues. The fact that glass fragments similar to production residues were found intensively in a small area raises the question of whether there was a glass workshop belonging to a later phase in the northeast corner of the church.

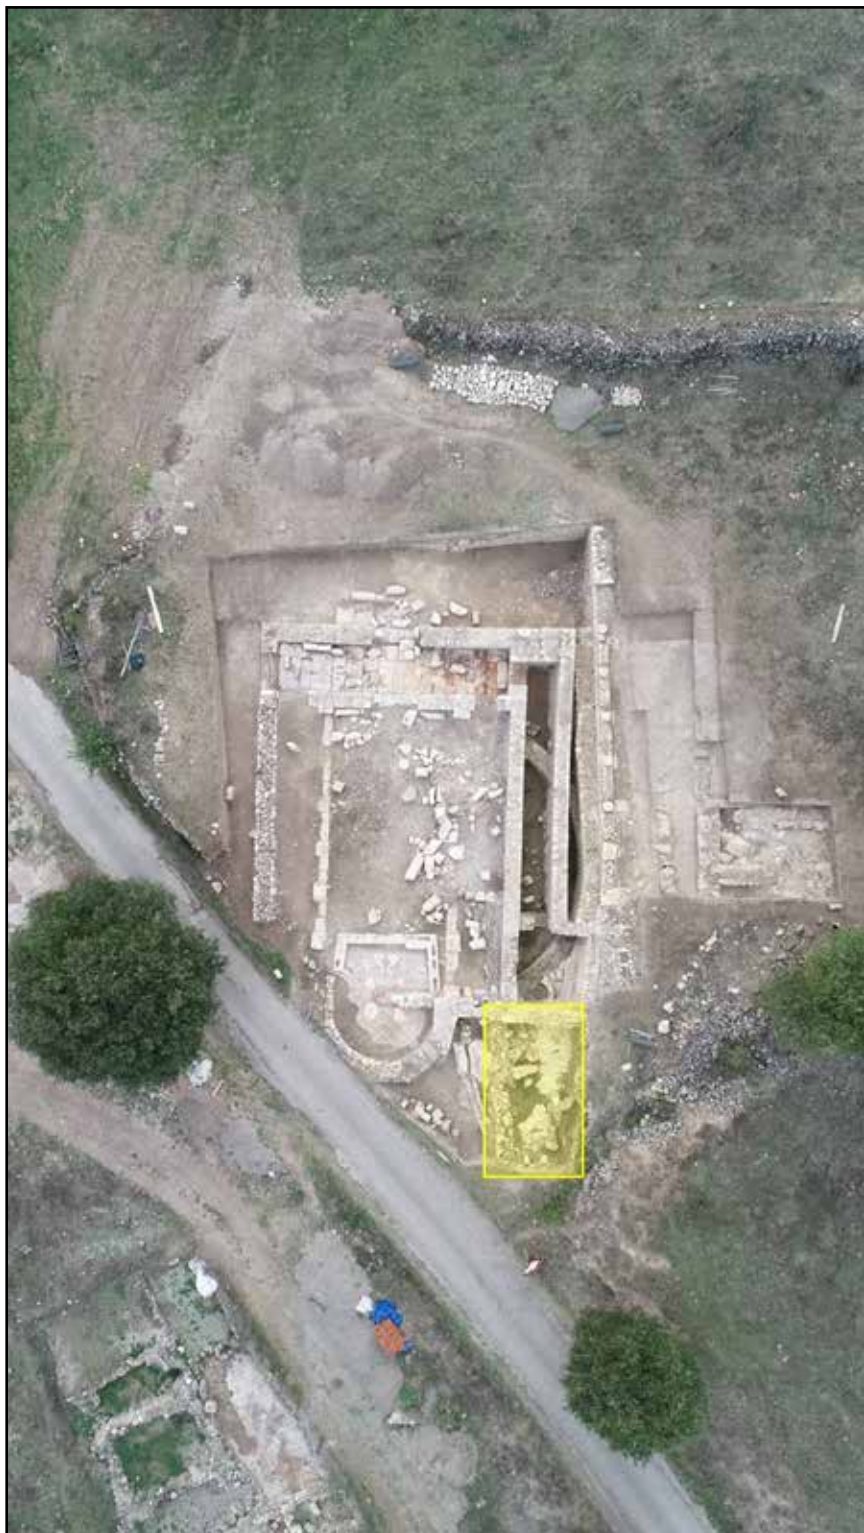
**Fig. 3.** Possible glass workshop of The Northwest Necropolis Church (Hadrianopolis Archive)

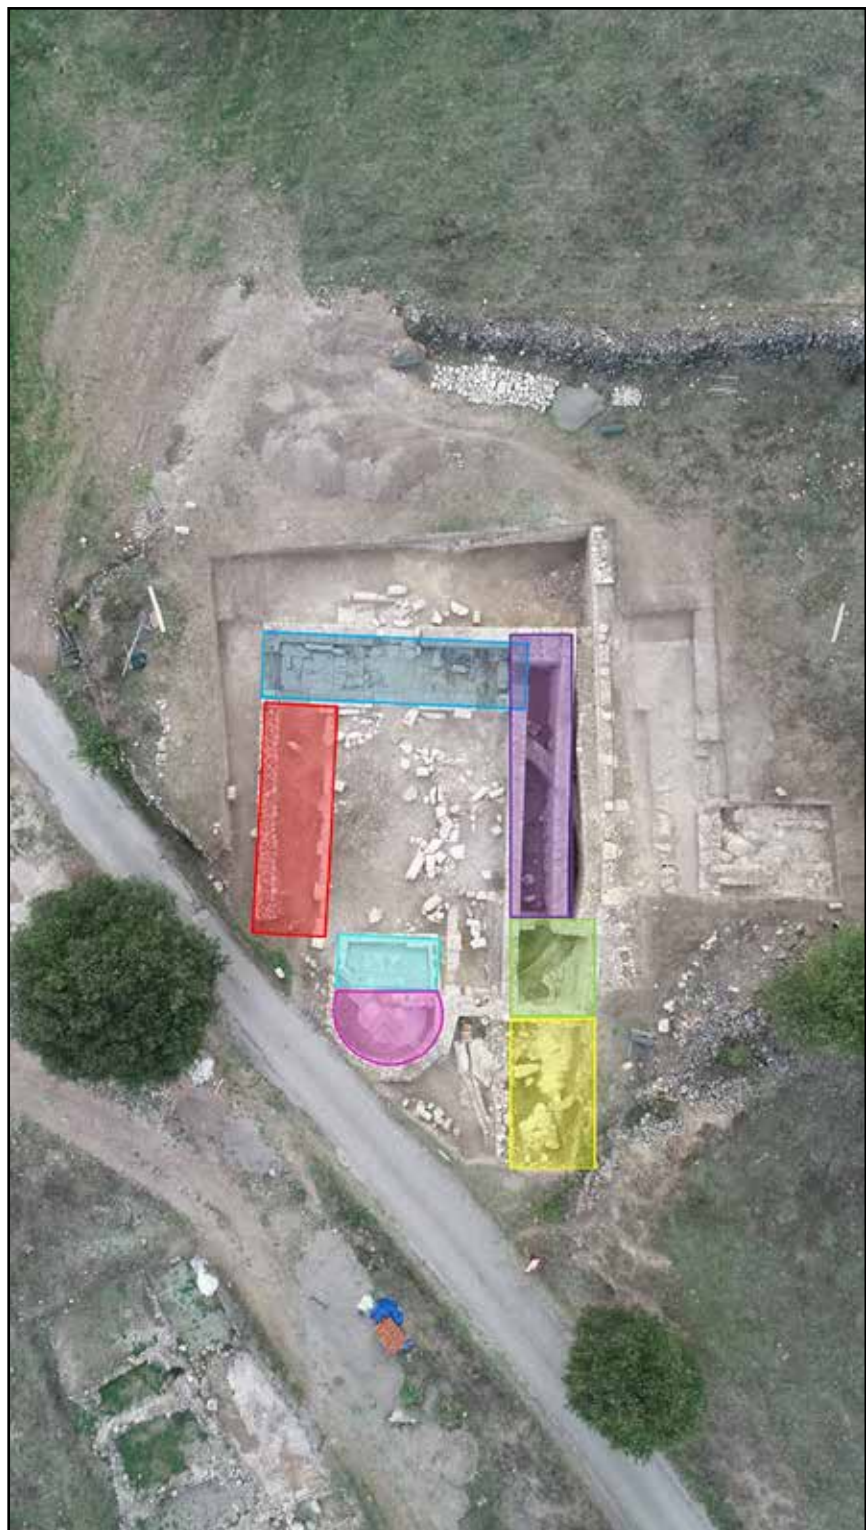
**Fig. 4.** Trenches with dense fragments of windowpanes (Hadrianopolis Archive)

During the scientific studies conducted in the church in 2017–2021, a total of 37 trenches were excavated. Fragments of windowpanes were found in almost all of the trenches (Fig. 4–5). It is highly probable that the points where the glasses were found intensively were close to the window of the building. When the windowpanes are analyzed in detail, it is seen that some of them are in the form of fragments, some of them are flat and have rounded edges at one end. It is thought that the rounded ends of these windowpanes were formed by taking the shape of the

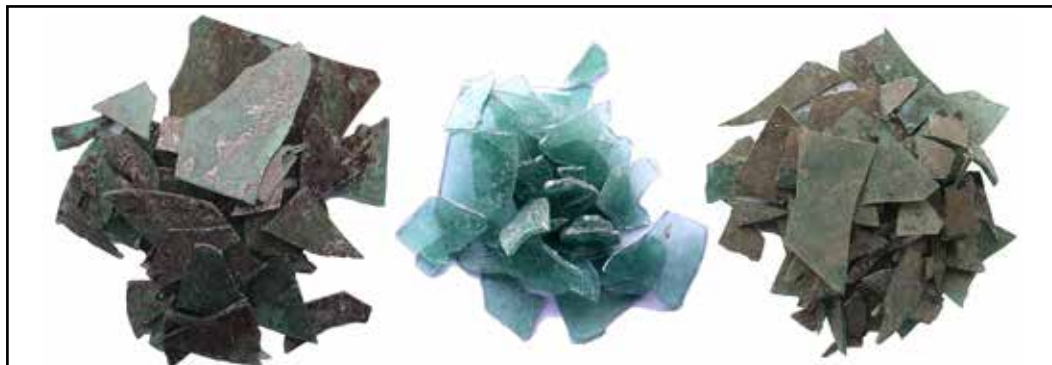
**Fig. 5.** The Fragments of windowpanes from The Northwest Necropolis Church (Hadrianopolis Archive)

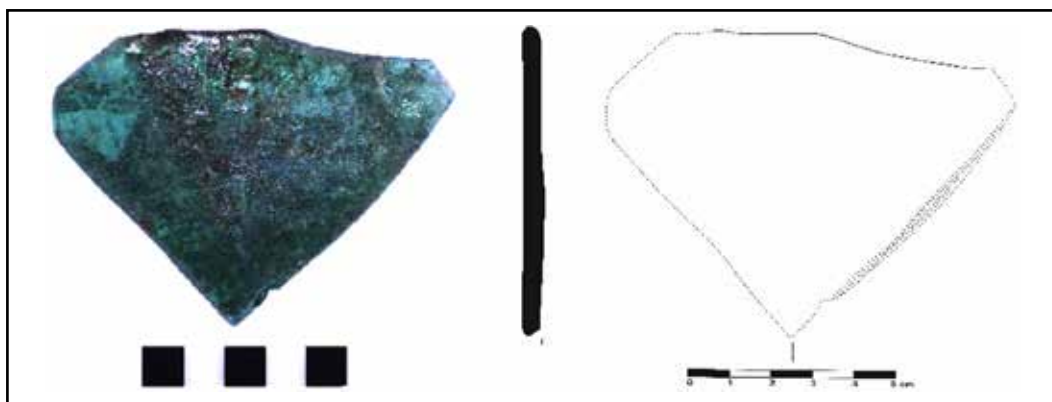
**Fig. 6.** The fragment of windowpane one rounded end made by casting production technique (Hadrianopolis Archive)

frame in which they were cast [12, p. 363], or they were rounded with the help of heat and tools, or they were placed inside the plaster and stone window frame seen in Middle Byzantine glazing (Fig. 6) [2, p. 152–153]. Cylinder blowing technique was identified in the production of the windowpanes found in the church (Fig. 7). The thickness of the glass produced in this technique was measured between 2–4 mm. It is known that the air bubbles in the glass produced in the cylinder blowing technique are elliptical or spindle-shaped due to the blowing. The remains of paste on the windowpanes found in the church indicate that the panes were fastened to the frame with the help of paste [7, p. 15–101]. The different thicknesses of the glass must have resulted from the fact that thin glass was used to benefit from heat and light in the parts where the sun was intense, while thick glass was used to prevent light and heat loss in places where the sun was not seen.

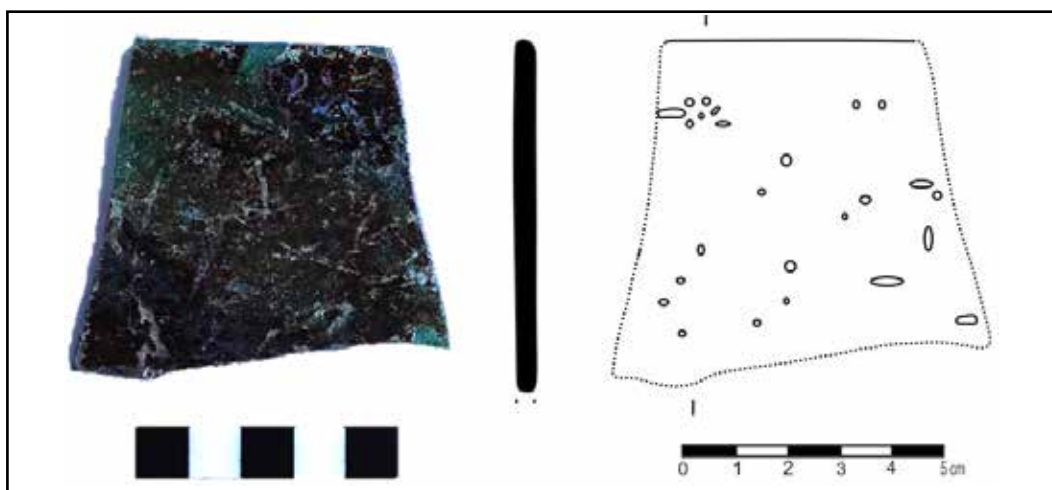
**Fig. 7.** A fragment of widowpanes made by Cylinder blowing technique (Hadrianopolis Archive)

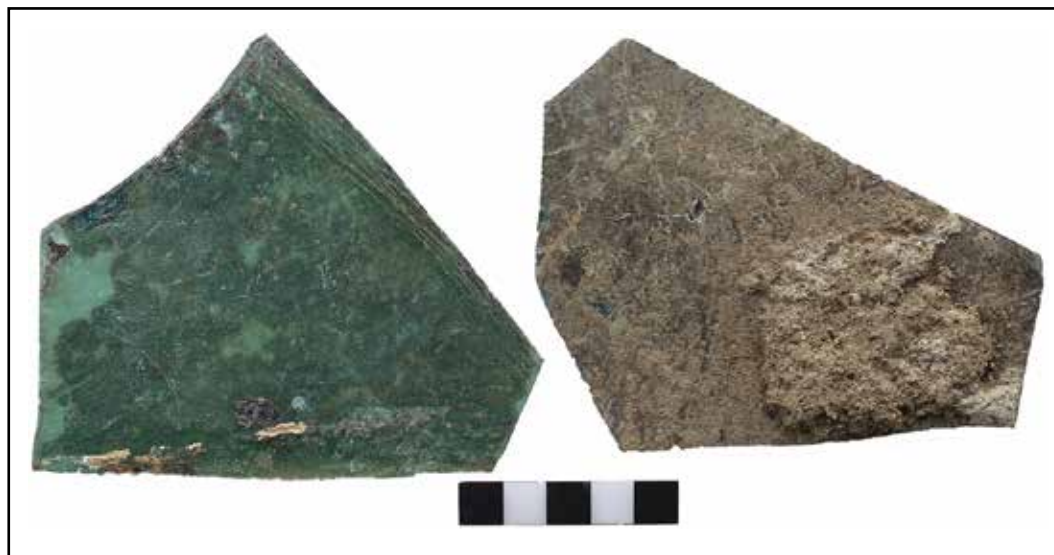
Fig. 8. Fragments of windowpanes with paste and mortar (Hadrianopolis Archive)

Remains of paste and mortar (Fig. 8) were found on the windowpanes unearthed in the Northwest Necropolis Church, indicating that the glass was fixed to the window grid with putty. Archaeometric analyses were carried out on the putty in order to find out from which materials the putty residue seen on the windowpane was obtained. The presence of lime ( $\text{CaCO}_3$ ) as an inorganic substance was found in the powdered putty sample whose spectrum was taken with the Bruker brand Alpha model ATR FTIR device. However, there is only one peak which is thought to be gypsum ( $\text{CaSO}_4$ ). As an organic substance, a resin of animal origin, which may be “shellac”, was found to be used<sup>1</sup> (Fig. 9).

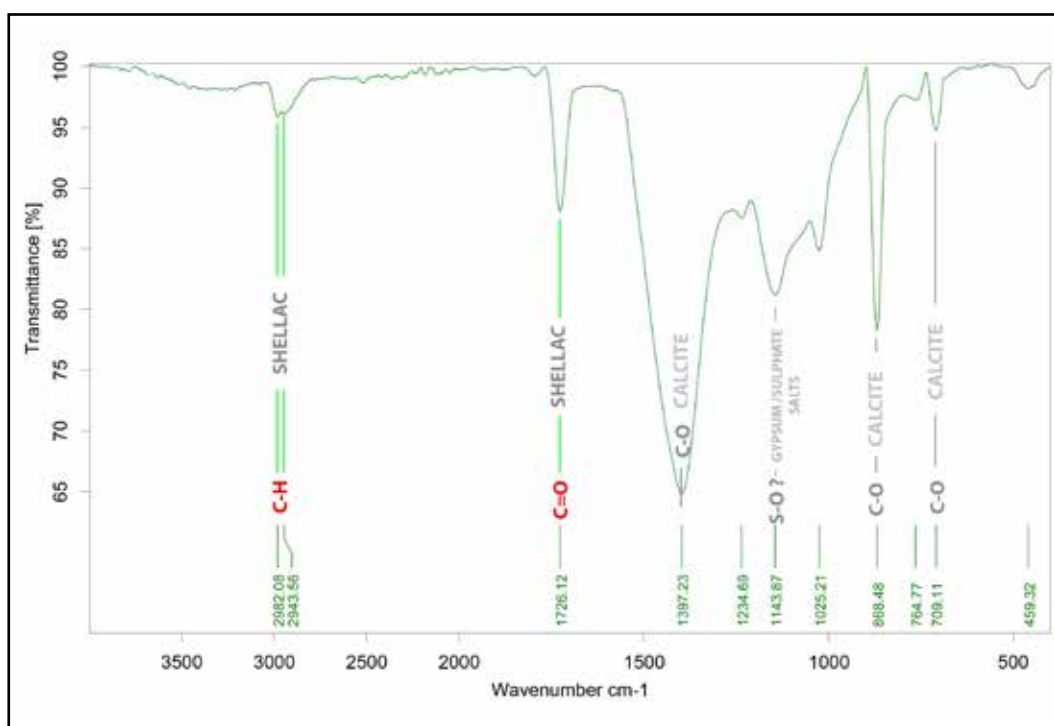
Fig. 9. Analysis Graphic of Paste

The shellac detected in the paste on the windowpanes is a thin, transparent, honey-colored resin of insect origin [13, p. 38–39]. Archaeometric studies have proven that the shellac on the windowpanes found in the church was not transparent and was obtained by mixing it with lime. The use of shellac was intended to better seal small cracks, to reduce the water absorption of lime particles, to ensure the longevity of the paste and to provide a glassy layer. Shellac is actually a resin that is not only used for insulation purposes; it is a resin that increases the durability and longevity of the materials used for insulation purposes [13, p. 39]. In addition, since it is a glassy layer, it also increases the water resistance of the places where it is used. The cold and rainy winters in the region where Hadrianopolis is located must have been the main factor that led to the use of shellac, which increases thermal insulation in buildings.
